# FOURTH FIVE-YEAR REVIEW REPORT

## Bally Ground Water Contamination Superfund Site

Borough of Bally

Berks County, Pennsylvania

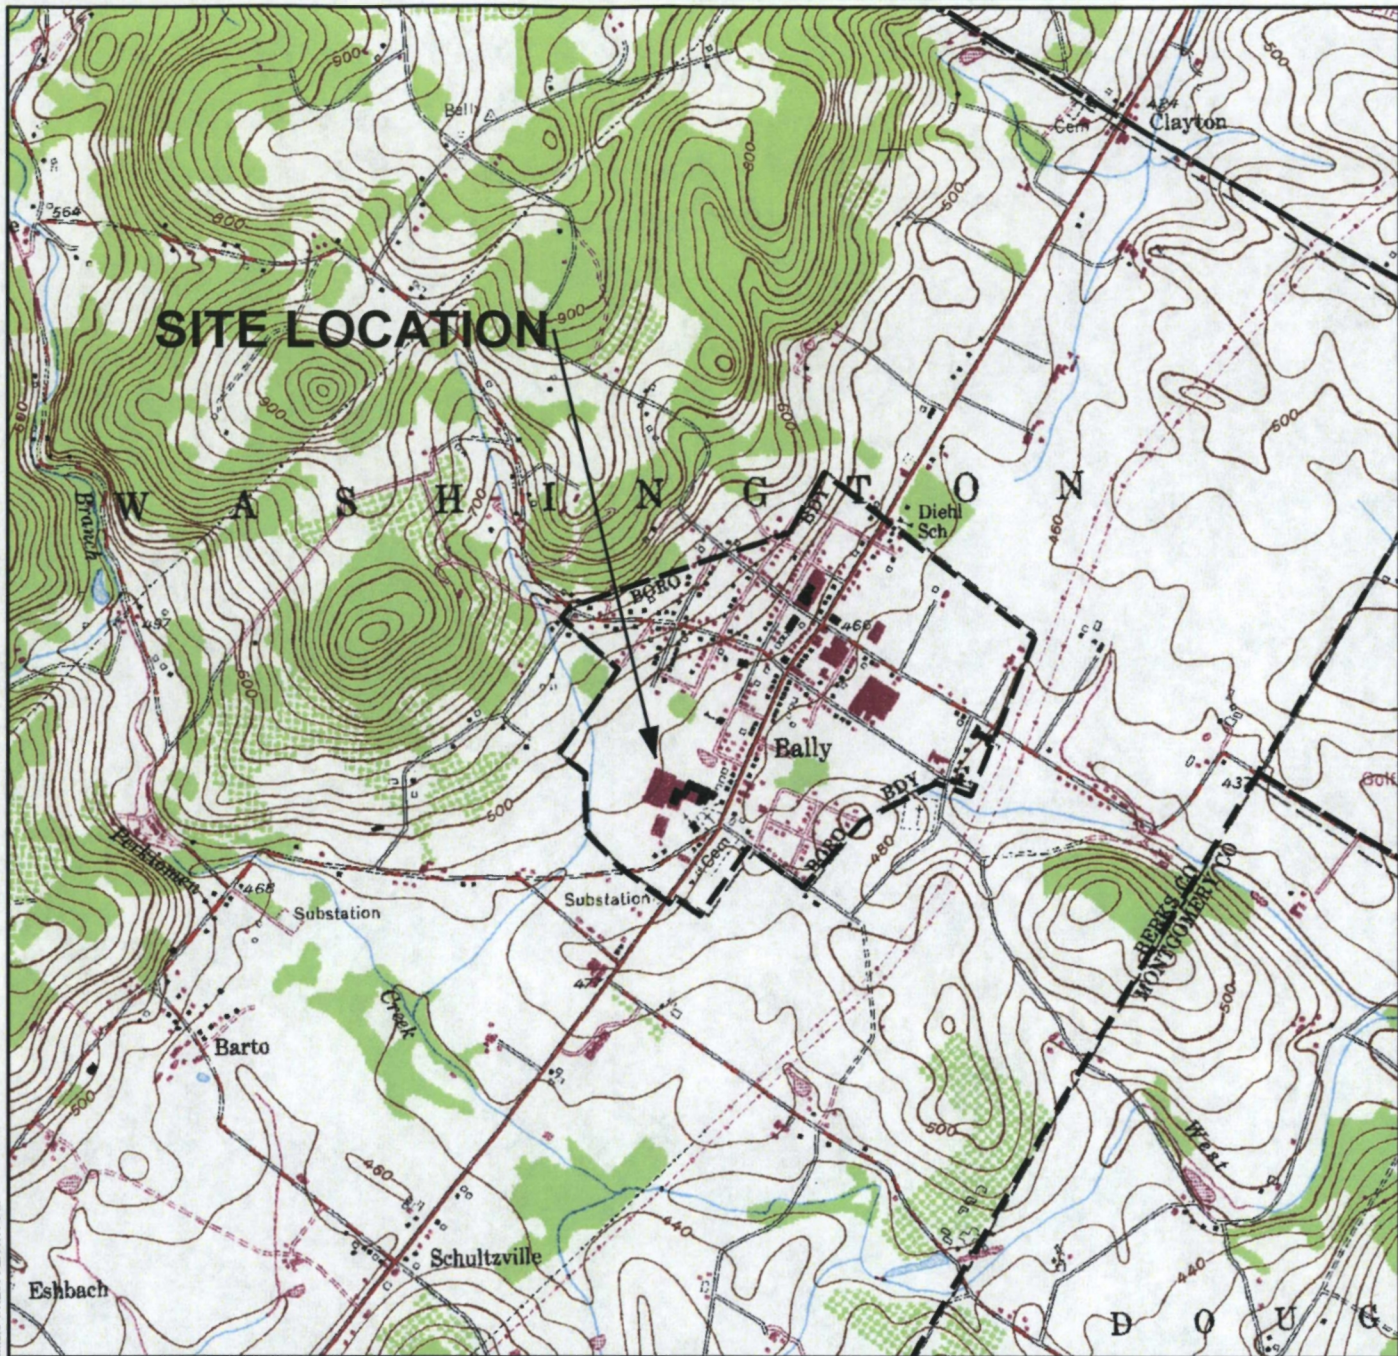
Attachment 2 Site Plan

Adopted from Remedial Action Progress Report, dated December 8, 2014
